MMC Materials, Inc.
TNG110370 - Frayser Plant

Project No.:	Site Location:	Permittee:	Date:	Time On-Site
TNG110370	2941 Frayser Blvd., Memphis, Shelby County, TN	MMC Materials, Inc.	Sept. 26, 2016	15:45 PM

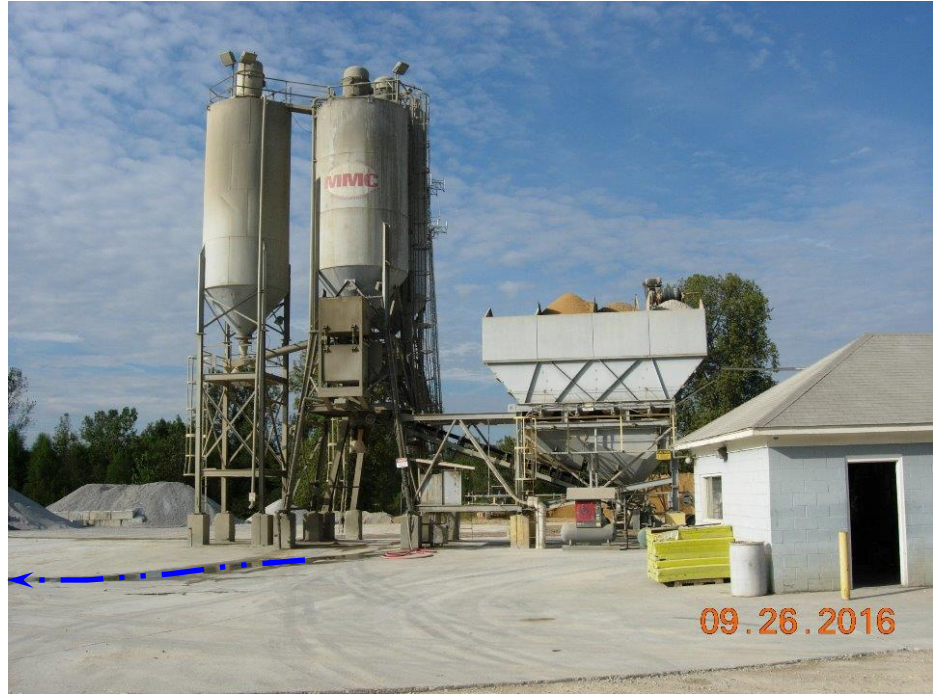
Photo No.	Photographer
1	Cliff Caudle

View north toward the batch plant. Portland cement is stored and dispensed into the batch process from the tall silos in the center. Runoff from the batch plant drains to the west toward the multi-basin treatment system (arrow).

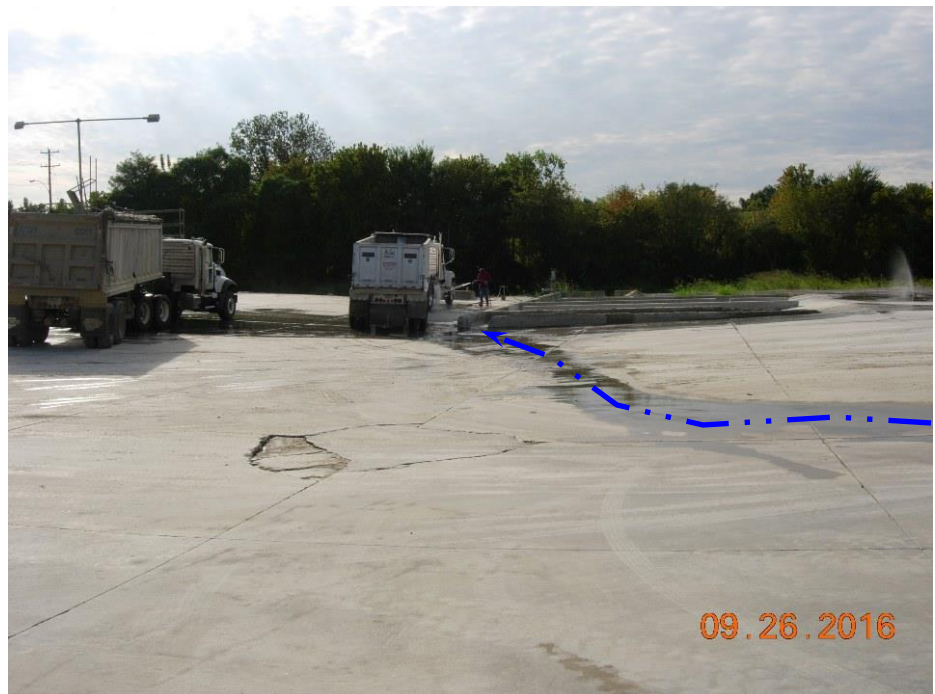
Photo No.	Photographer
2	Cliff Caudle

View west toward the truck wash station area and the multi-basin treatment system. The wash rack is to the left in the photo. Note the runoff from the batch plant area (arrow) to the right in the photo, also shown in Photo 1.

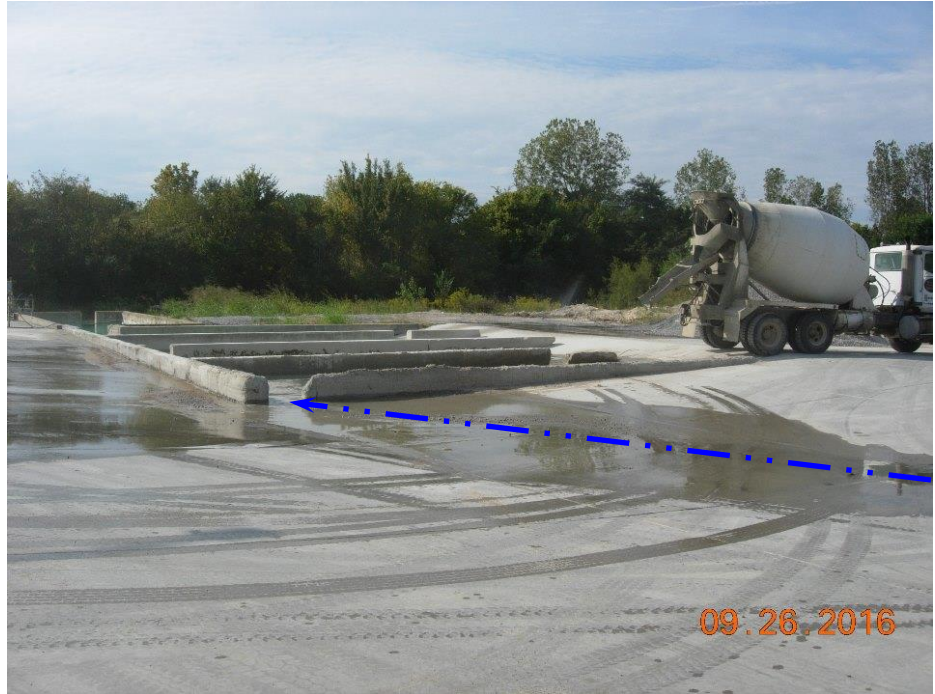
Photo No.	Photographer
3	Cliff Caudle

View north-northwest showing the inflow point to the five-cell treatment basin system.

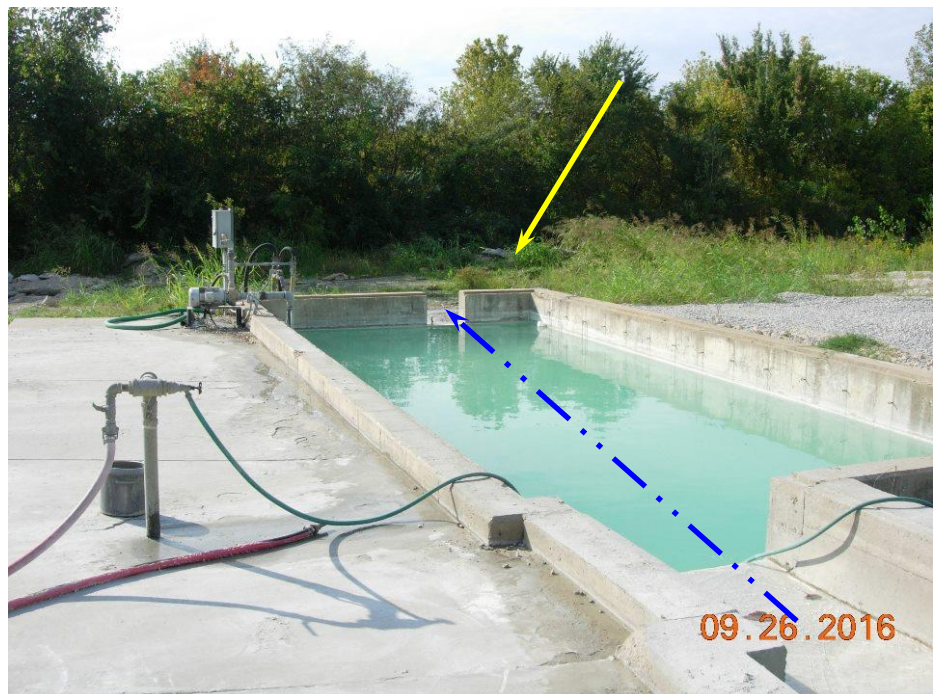
Photo No.	Photographer
4	Cliff Caudle

View west showing the exit point from the last cell in the multi-basin treatment system. The yellow arrow denotes the location of designated Outfall 001. No sign designating Outfall 001 was observed on the site.

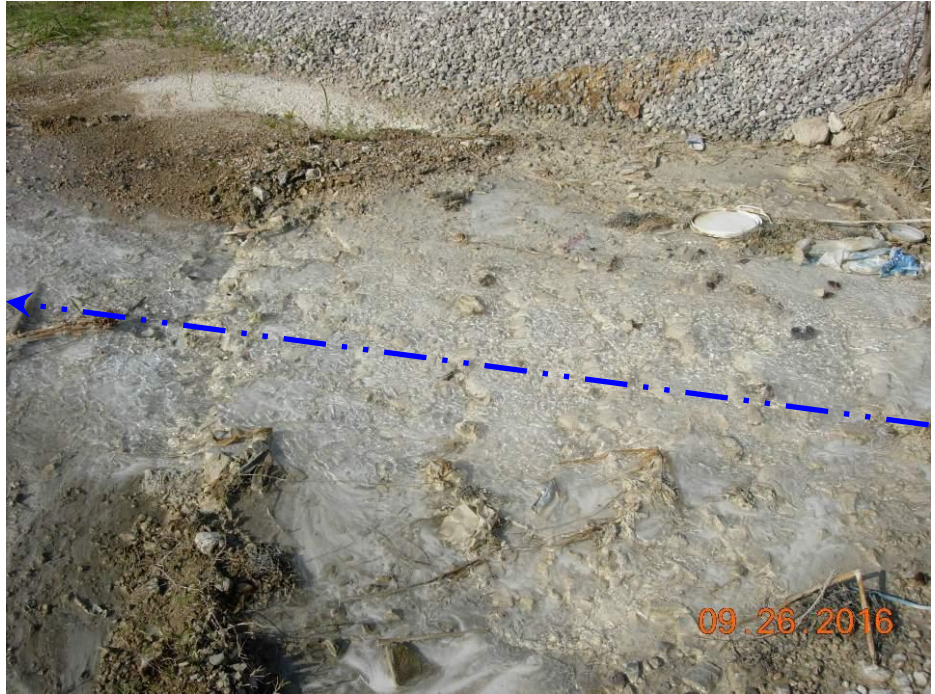
Photo No.	Photographer
5	Cliff Caudle

Close-up view west of, and immediately down-gradient of, the multi-basin process water treatment system. The water in the photo was flowing over a hardened cement residue, and was clear at the time of the inspection.

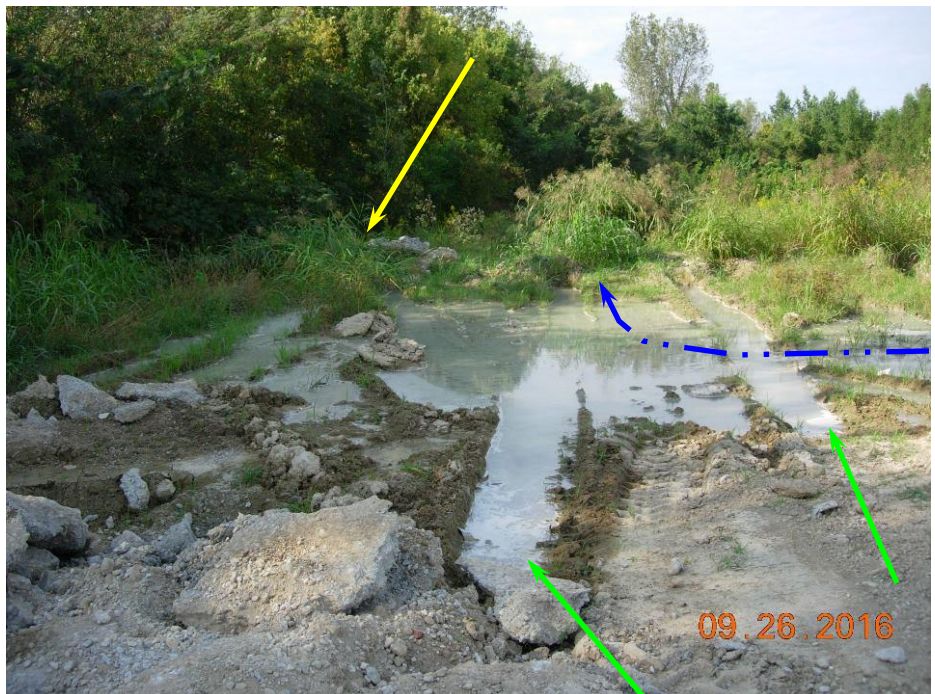
Photo No.	Photographer
6	Cliff Caudle

View north showing the on-site collection point for process water after it leaves the multi-basin treatment system. Though the area shown had a thin veneer of cementitious material and a minor amount of floating residue (green arrows), the water itself was mostly clear at the time of the inspection. The blue arrow shows the flow direction from the treatment basins to the low area west of the basins. The yellow arrow shows the location of Outfall 001 to the perimeter drainage ditch (see Figures 1 and 2).

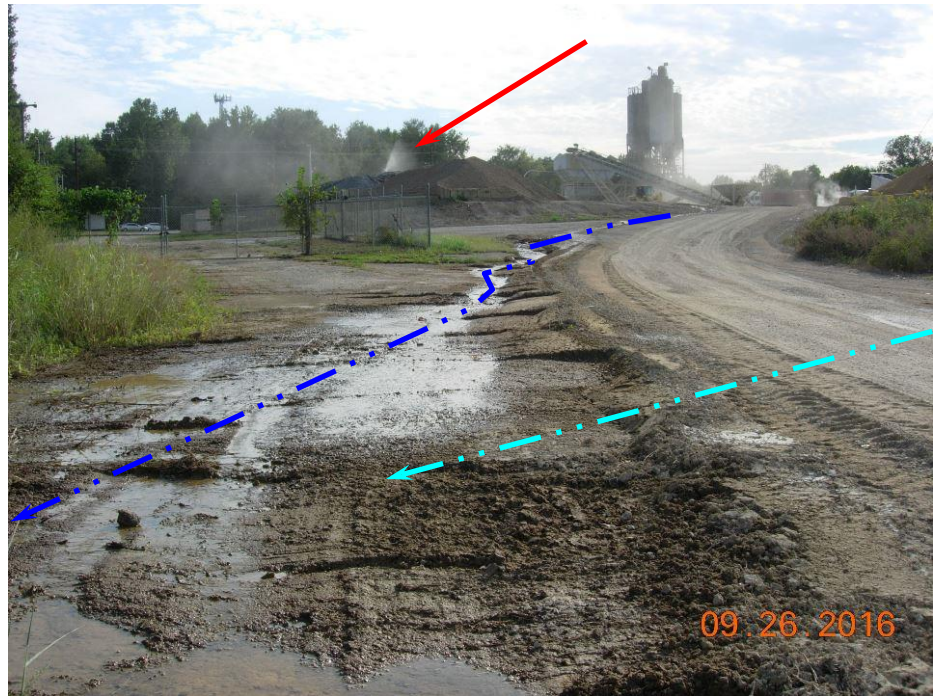
Photo No.	Photographer
7	Cliff Caudle

View south showing the eastern low area that receives 1) process water flow (blue arrow) from the aggregate stockpile watering (red arrow) on the east side of the batch plant, and 2) potential process water flow (teal arrow) from the treatment basins via the diversion ditch along the north side of the batch plant (Fig. 1). The water - mostly clear at the time of the inspection - collects and infiltrates at this location (see Fig. 1). Flow from this area would exit the site to the left (east) of the area shown.

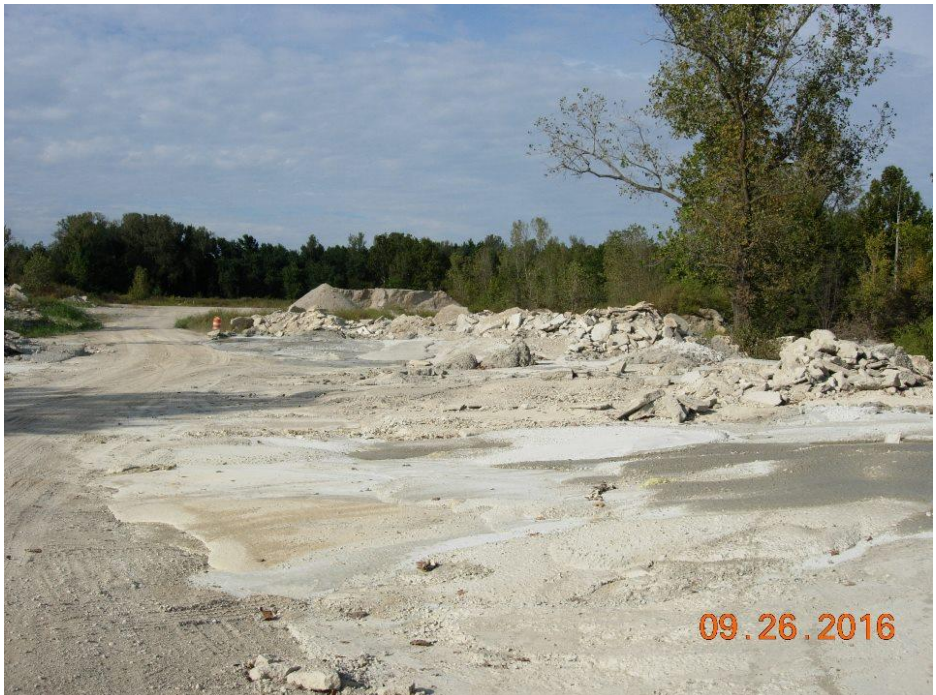
Photo No.	Photographer
8	Cliff Caudle

View north, from north of the batch plant. Excess concrete and concrete washout from ready-mix trucks is stockpiled on-site and later crushed for sale as fill material. This portion of the site drains westward toward the site interior. See Figure 2 – Overall Site Layout.
